# TESTREPORT – LIFETIME

*Multimec switch 5ETH935*

*Test no. 1204100 - April 2012*

Title: Lifetime test pushbutton switch type 5ETH935

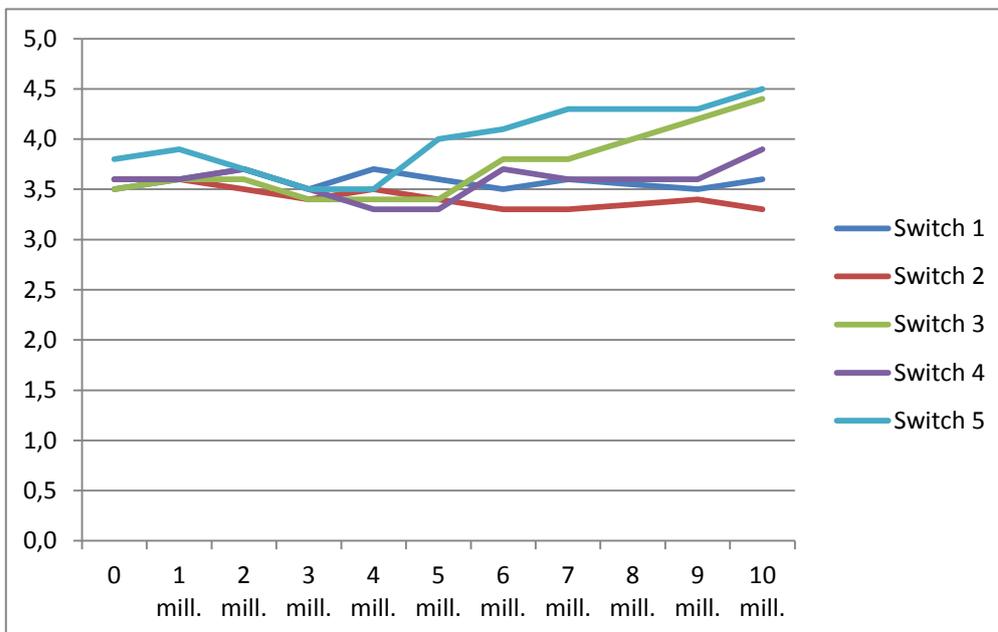
Test PASSED, 5/5 are within limits after 10 million activations.

*Note: there is a slight trend that the activation force increases over time.*

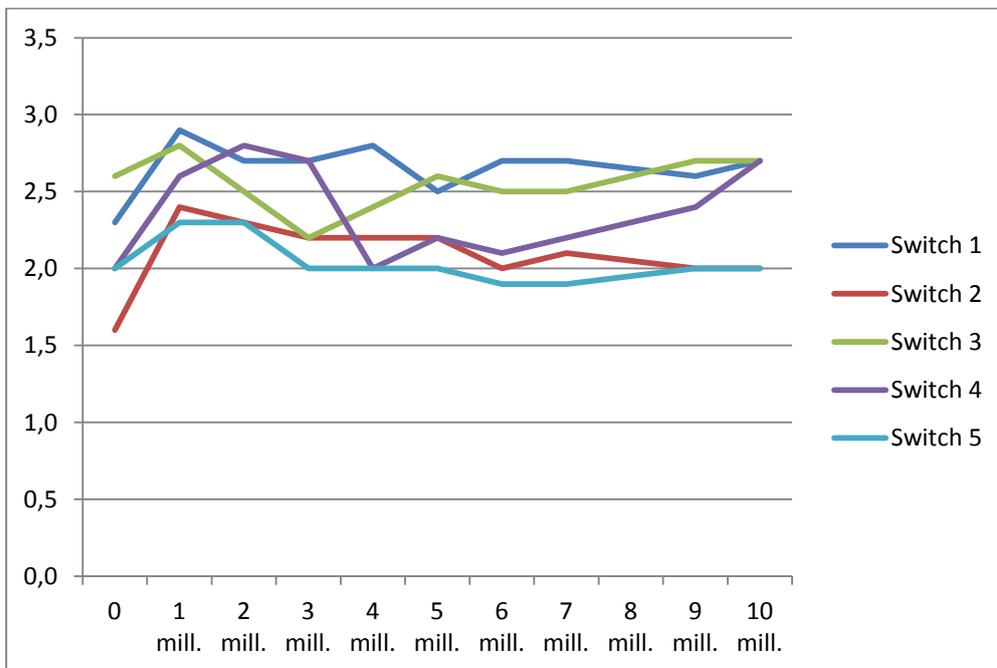
Test PASSED, 5/5 are within limits after 10 million activations.

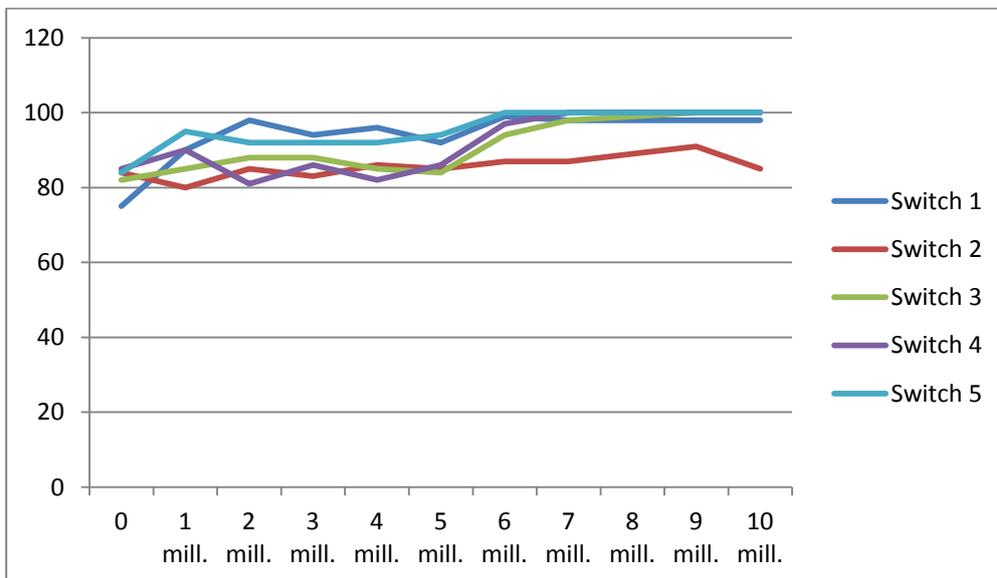
Test PASSED, 5/5 are within limits after 10 mill. activations.

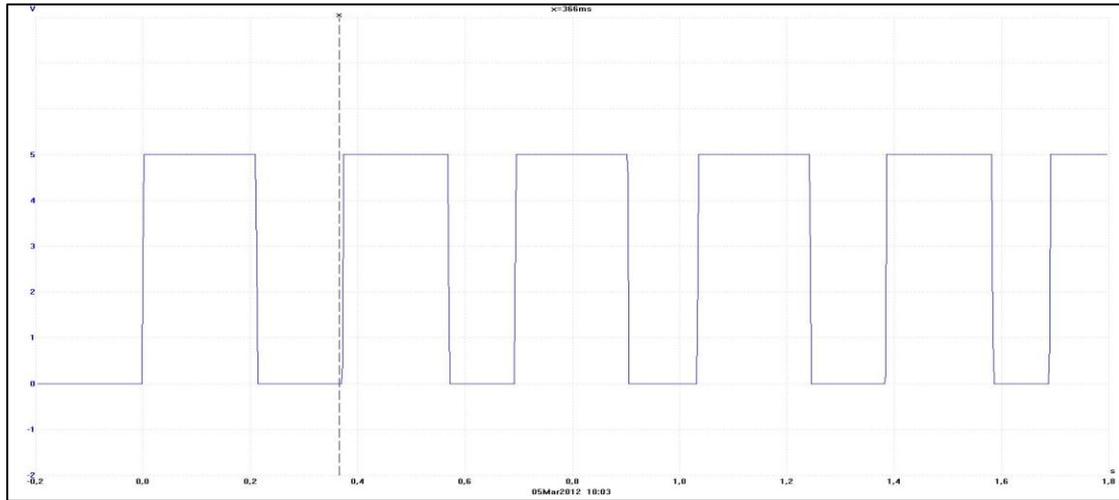
Test PASSED, 5/5 are within limits after 10 mill. activations.

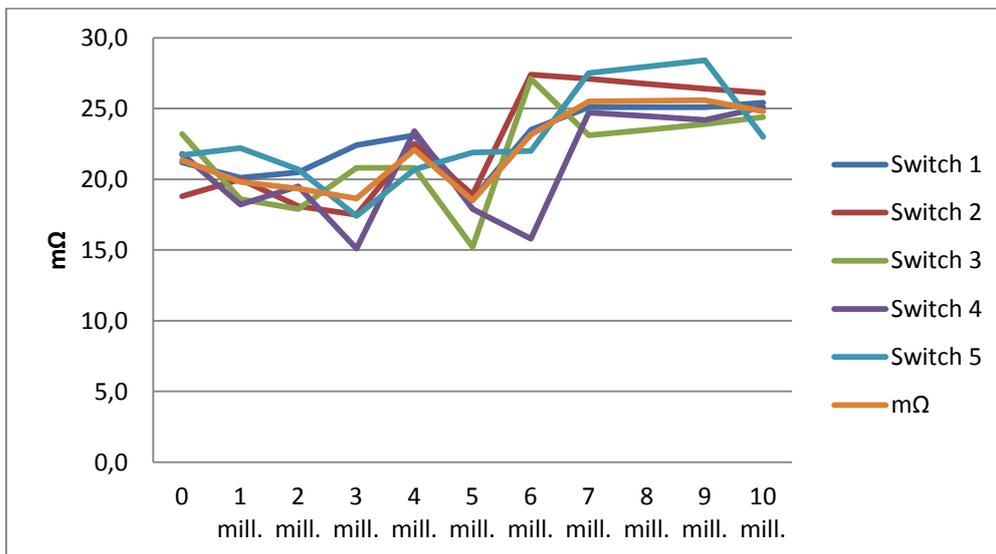
Test PASSED, 5/5 are within limits after 10 mill. activations.

Note: Contact resistance slightly increased over time

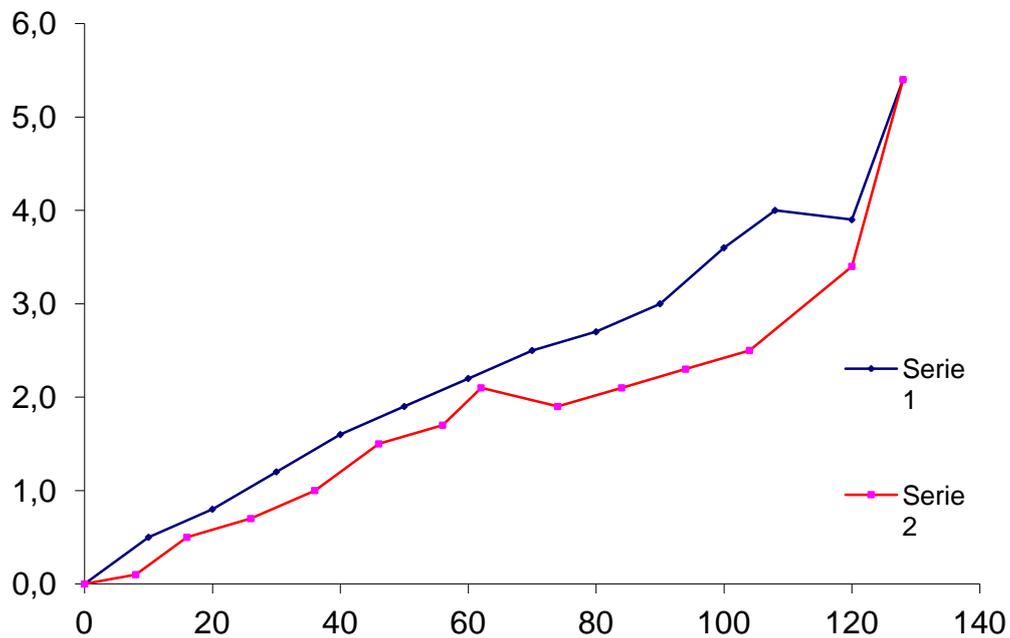
Test PASSED, clear indication of on & off-click.

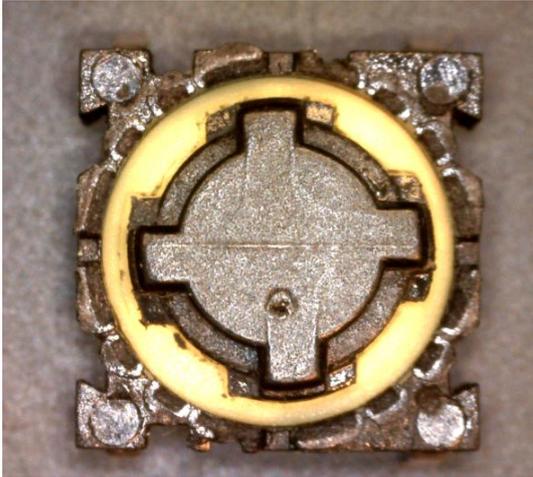
pic.1 illustrates topview of switch housing with removed lid

*Note lid & house is assembled by USW which explains the uneven surface of the housing.*

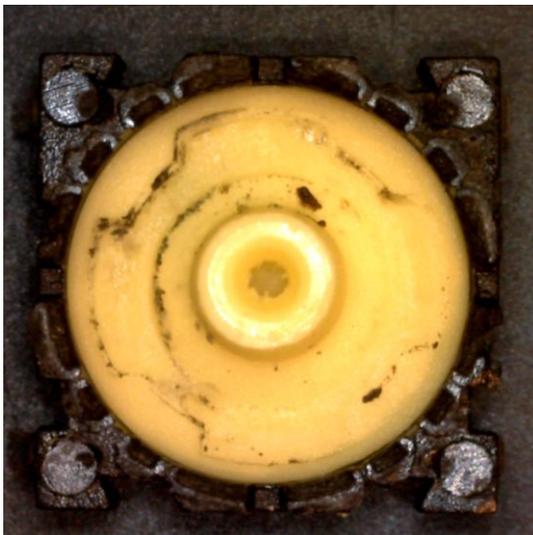
Pic.2 illustrates top view of housing , with removed actuator.

*Note Small amount of Oil smudge is found on the top part of the rubber plunger*

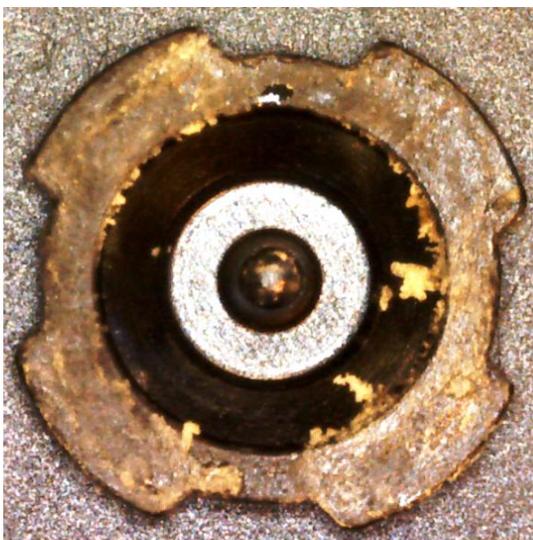
As illustrated at page 11 – the only irregular finding is the residual from oil vapor penetration that is caused by a fault/leakage in the gearbox in the test system.

pic.3 illustrates bottom view of the actuator.

*Note the residue is oily/grease caused by a leak in the gearbox system in the LTT-01 – causing penetration into the switch*

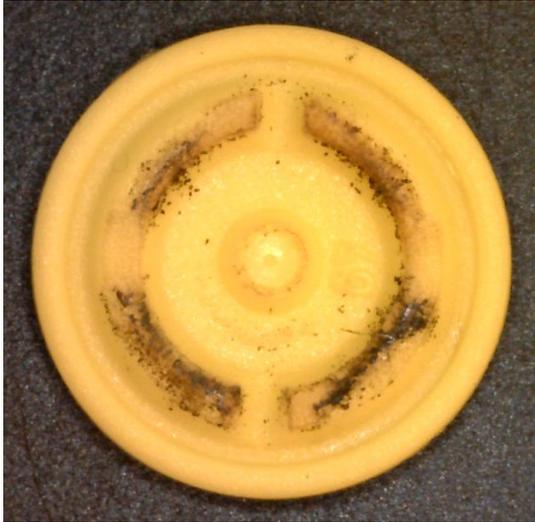
pic.4 Illustrates inside of the rubber plunger

*Note the indications of residual and their location could indicate high concentrations of oil fog in the test environment*

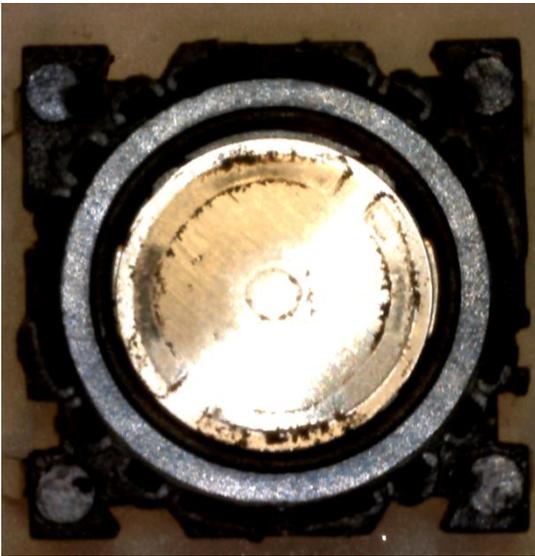
pic.5 illustrated topside of dome

*Note clear indication of where the rubber plunger aligns to the dome.*

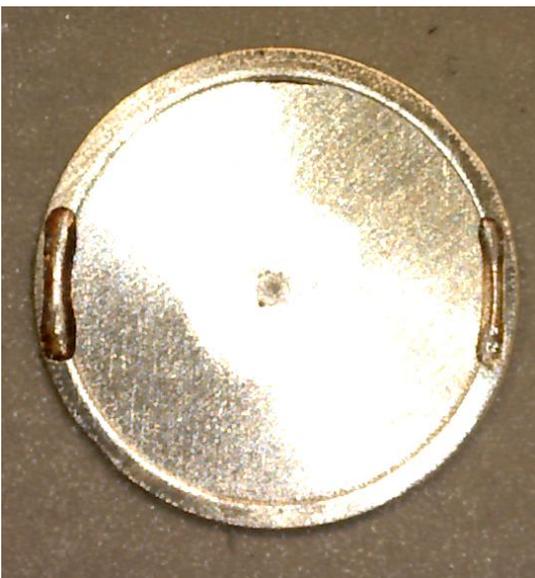
pic.6 illustrates the bottomside of the dome

*Note clear indications of the terminal points and the centercontact, but no functional/electrical impact measured*

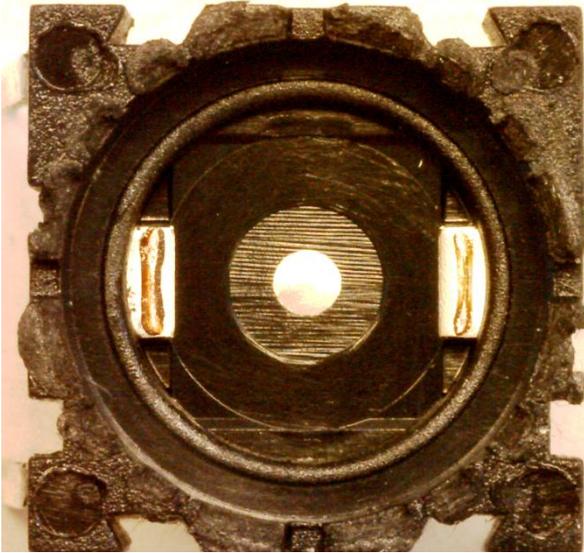
pic.7 illustrates top view of switchhouse without contact elements.  
*Note clear indications of the terminal points, but no functional/electrical impact measured*

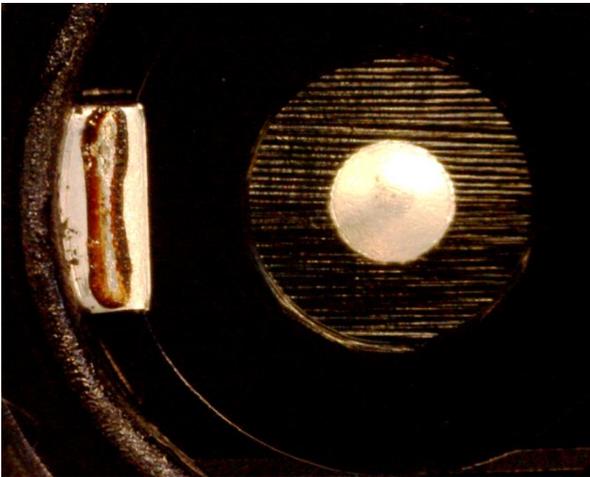
pic.8 illustrates contactpoint leftside and centerterminal.

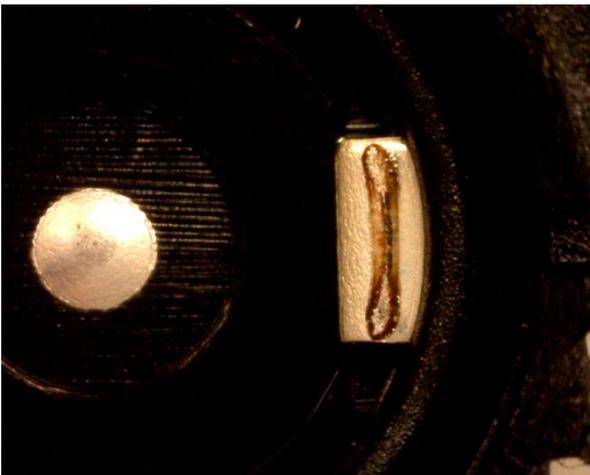
pic.9 illustrates contactpoint rightside and centerterminal.
