# TESTREPORT – LIFETIME

*Multimec switch 5ETH935*

*Test no. 1204100 - April 2012*

Title: Lifetime test pushbutton switch type 5ETH935

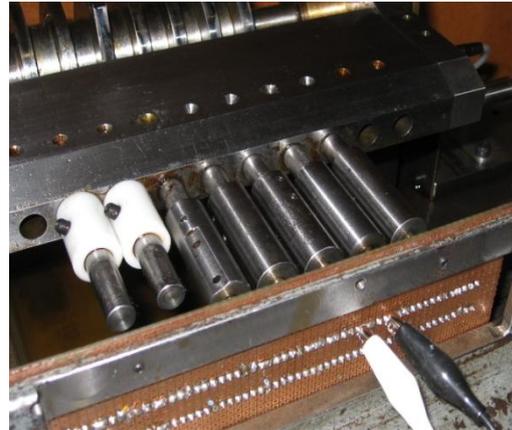
• Pic 2

Pic.2 illustrates top view of housing , with removed actuator.

*Note Small amount of Oil smudge is found on the top part of the rubber plunger*

*Note the residue is oily/grease caused by a leak in the gearbox system in the LTT-01 – causing penetration into the switch*
